**SITE ASSESSMENT  
UNION MINE GUN RANGE  
EL DORADO COUNTY, CALIFORNIA**

February 14, 2001

Kleinfelder Job No: 23-484495-B00

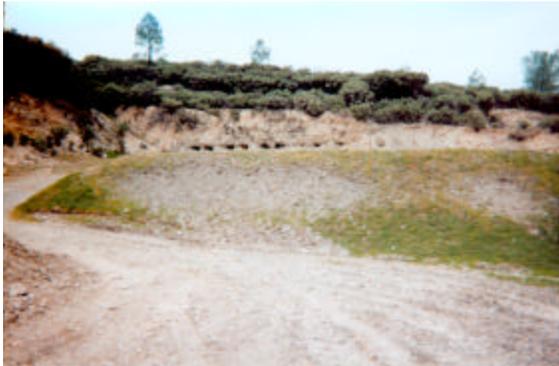
### Pistol and Large Bore Range

**Intermediate Berm**

Operations at the site included the use of wall berms and intermediate berms. Wall berms existed at the pistol ranges and the large bore range. The wall berms consisted of on-site material generally weathered bedrock and soil. The intermediate berms were located on the large bore range between the firing line and the wall berms. There are two such berms that are approximately 5 feet high (Plate 2A). The intermediate berms consisted of mostly sandy silt. Lime had been added to berms apparently to stabilize the lead.

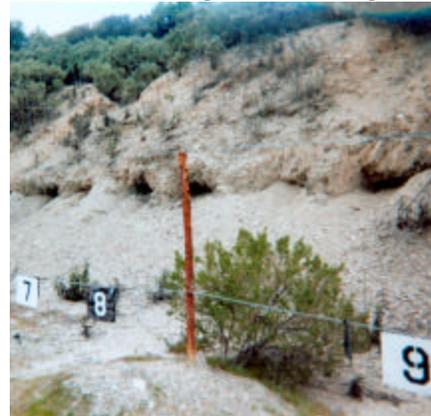
### Pistol and Large Bore Range

**End Wall Berm**

The highest lead result at the gun range site was 29,000 mg/kg at location S4 at the end wall berm at the pistol and large bore range. Many of the lead concentrations detected appear to be above background concentrations, and elevated lead concentrations ranging from 140 to 29,000 mg/kg were detected in 16 of the gun range samples. The residential PRG for lead is 400 mg/kg, and nine gun range samples had lead levels above the residential PRG.

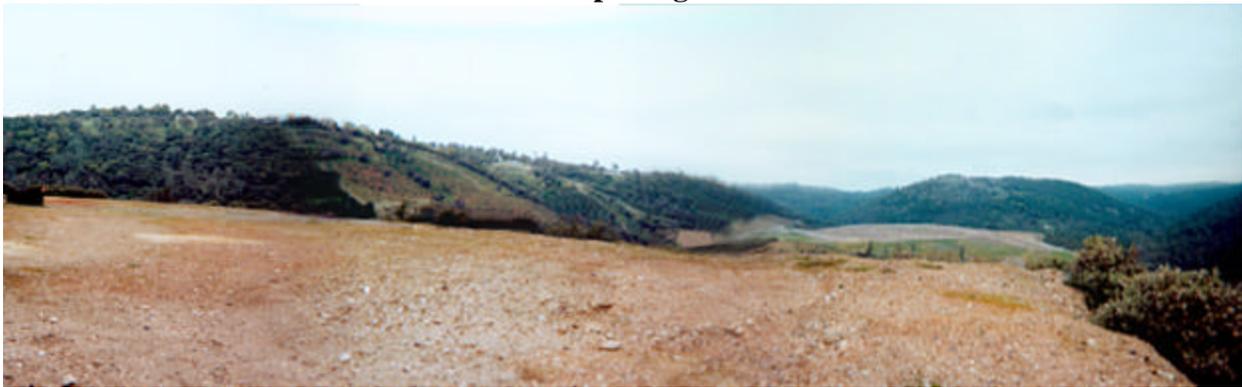
### Trap Range

The trap range consisted of a relatively flat compacted gravel surface. The north slope of the range consisted of loose rock on a fairly steep slope. This slope flattened out as it continued northward. As the slope flattened out, soil conditions consisted of mostly sandy silt with rock, roots and vegetation debris. Vegetation on the hillside consisted of mostly mountain manzanita and poison oak which was thick near the top of slope and thinned out as the slope extended downward to the north. "Clay pigeons" were observed on the north side of the trap range to approximately 300 feet north of the trap shacks. The largest amount was observed between 75 and 150 feet north of the trap shacks. Shot pellets were not observed on the hillside.

The trap range is situated east of the gun range at a higher elevation. "Clay pigeons" are shot directly north from the range. On the north side of the trap range is a slope that extends approximately 600 to 800 feet to an intermittent stream that runs down from the gun range and separates the gun range property from the adjacent landfill property. According to El Dorado County employees, shot from the trap range has landed as far as the adjacent Union Mine landfill property on the north side of the intermittent stream.

- Trap Range – Elevated semi-volatile organic constituents (PAHs) were detected in the two soil samples analyzed from one location at the trap range. It is assumed that the detected constituents are associated with the “clay pigeons” used at the range. The samples analyzed for semi-volatile organic constituents were not screened or sieved, and “clay pigeon” fragments were observed in the duplicate shallow sample sieved from S36. It is possible that a piece of “clay pigeon” may have been digested during the analysis, therefore elevating the PAH results. Additional soil sampling can be performed, and the samples screened prior to analysis to confirm that fragments are not included in the samples. El Dorado County may want to evaluate the composition of the “clay pigeons” used at the site. If soluble PAHs are present in the “clay pigeons” currently used at the site, El Dorado County may want to investigate whether alternative products are available.

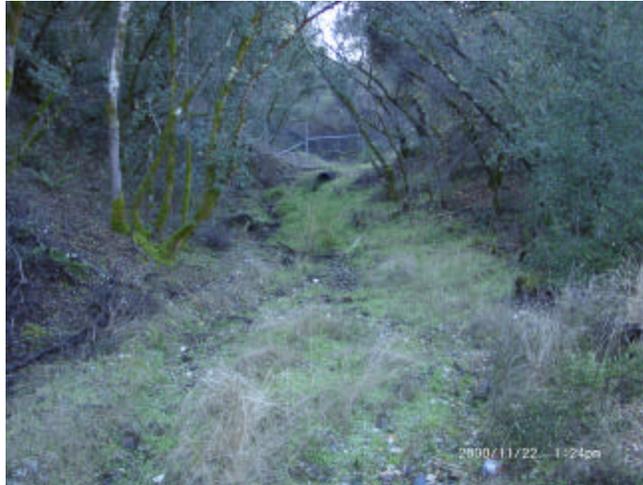
### Surface Water Sample Location from Culvert

In addition to the 46 soil sample locations, one surface water sample (109080) was collected from the drainage below the trap and gun ranges. A surface water sample from the intermittent creek immediately down slope of the gun range was not collected due to the dry weather and lack of water. Therefore, a sample of first encountered surface water below the two ranges was collected as it exited through a culvert at the bottom of the hill. The surface water sample was collected in a clean,

unpreserved, polyethylene container. The sample was collected by holding the container under a culvert outlet. The sample was placed on ice and transported under chain-of-custody controls to Kleinfelder's sample control.

The surface water sample collected from the drainage culvert at the bottom the hill was analyzed for the four gun range metals. Copper, nickel and lead were not detected above laboratory reporting limits in the water sample. A low concentration of zinc was detected at 23 ug/L in the water sample. The secondary Maximum Contaminant Level (MCL) for zinc in drinking water is 5,000 ug/L. This sample may not be representative of gun range runoff during wet conditions or storm events; therefore, additional sampling may be warranted during a storm event to better evaluate potential impact to surface water.
